Westinghouse Astronuclear Laboratory

WANL-TNR-224

NRX-A6 FINAL REPORT

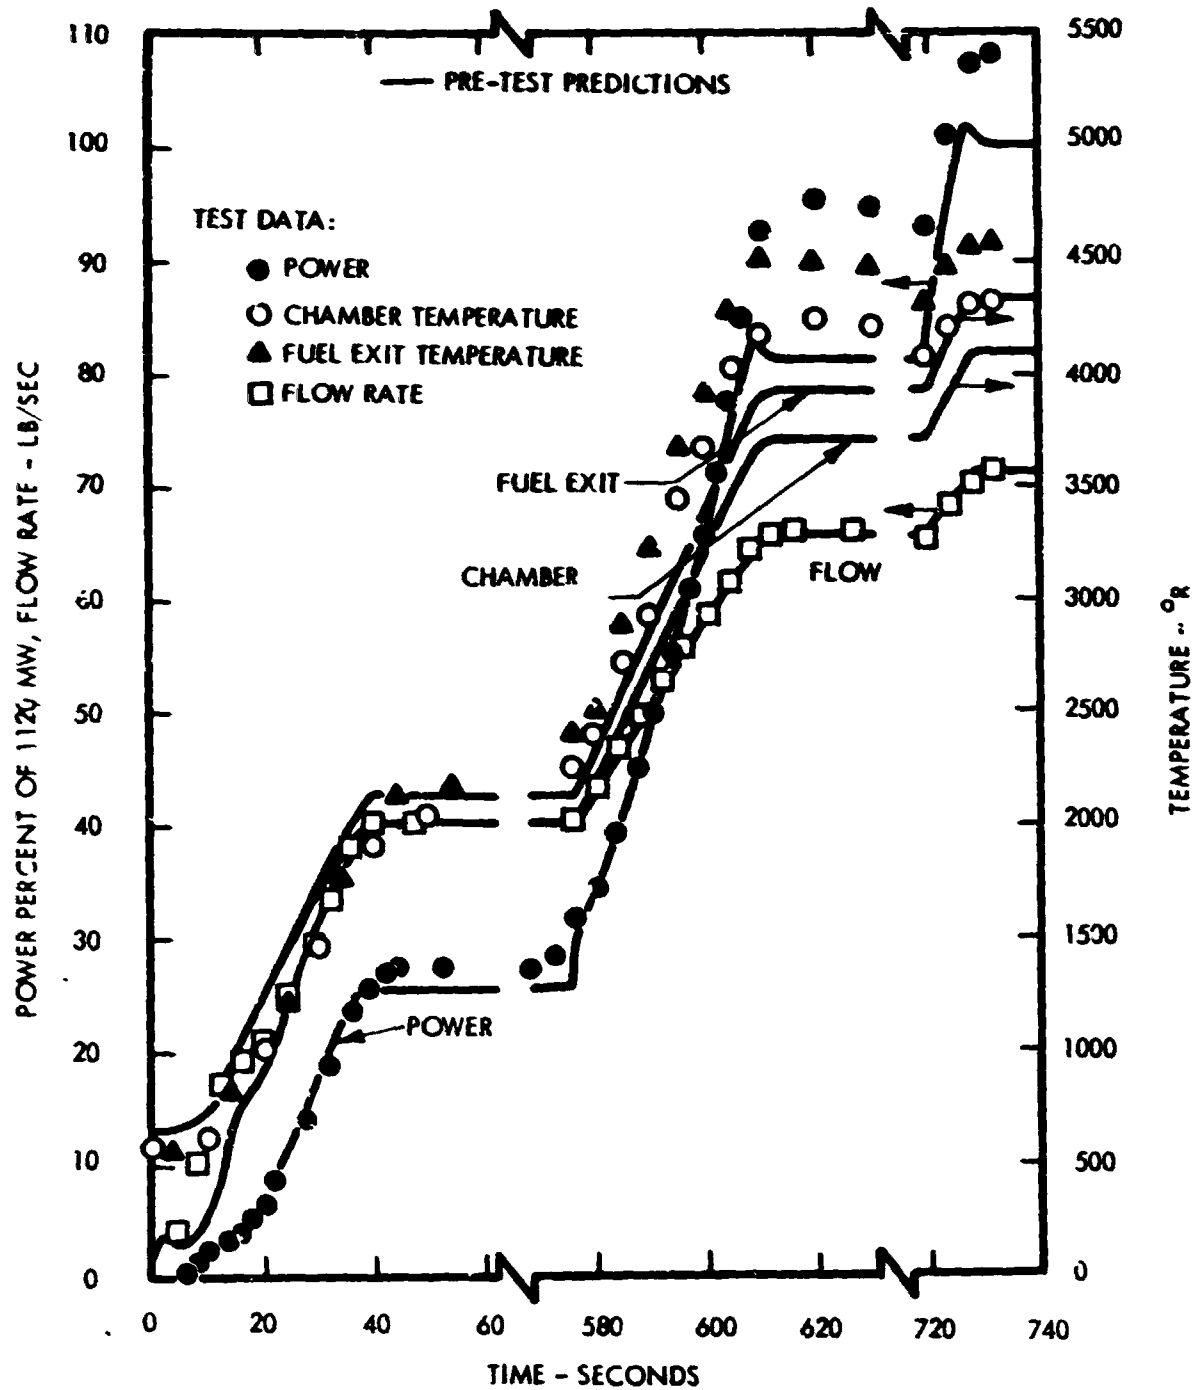
Figure 5-2. (CRD) Comparison of Power, Nozzle Torus Flow, Average Fuel Exit and Chamber Temperature Predictions with Measurements During EP-III A Startup (U)

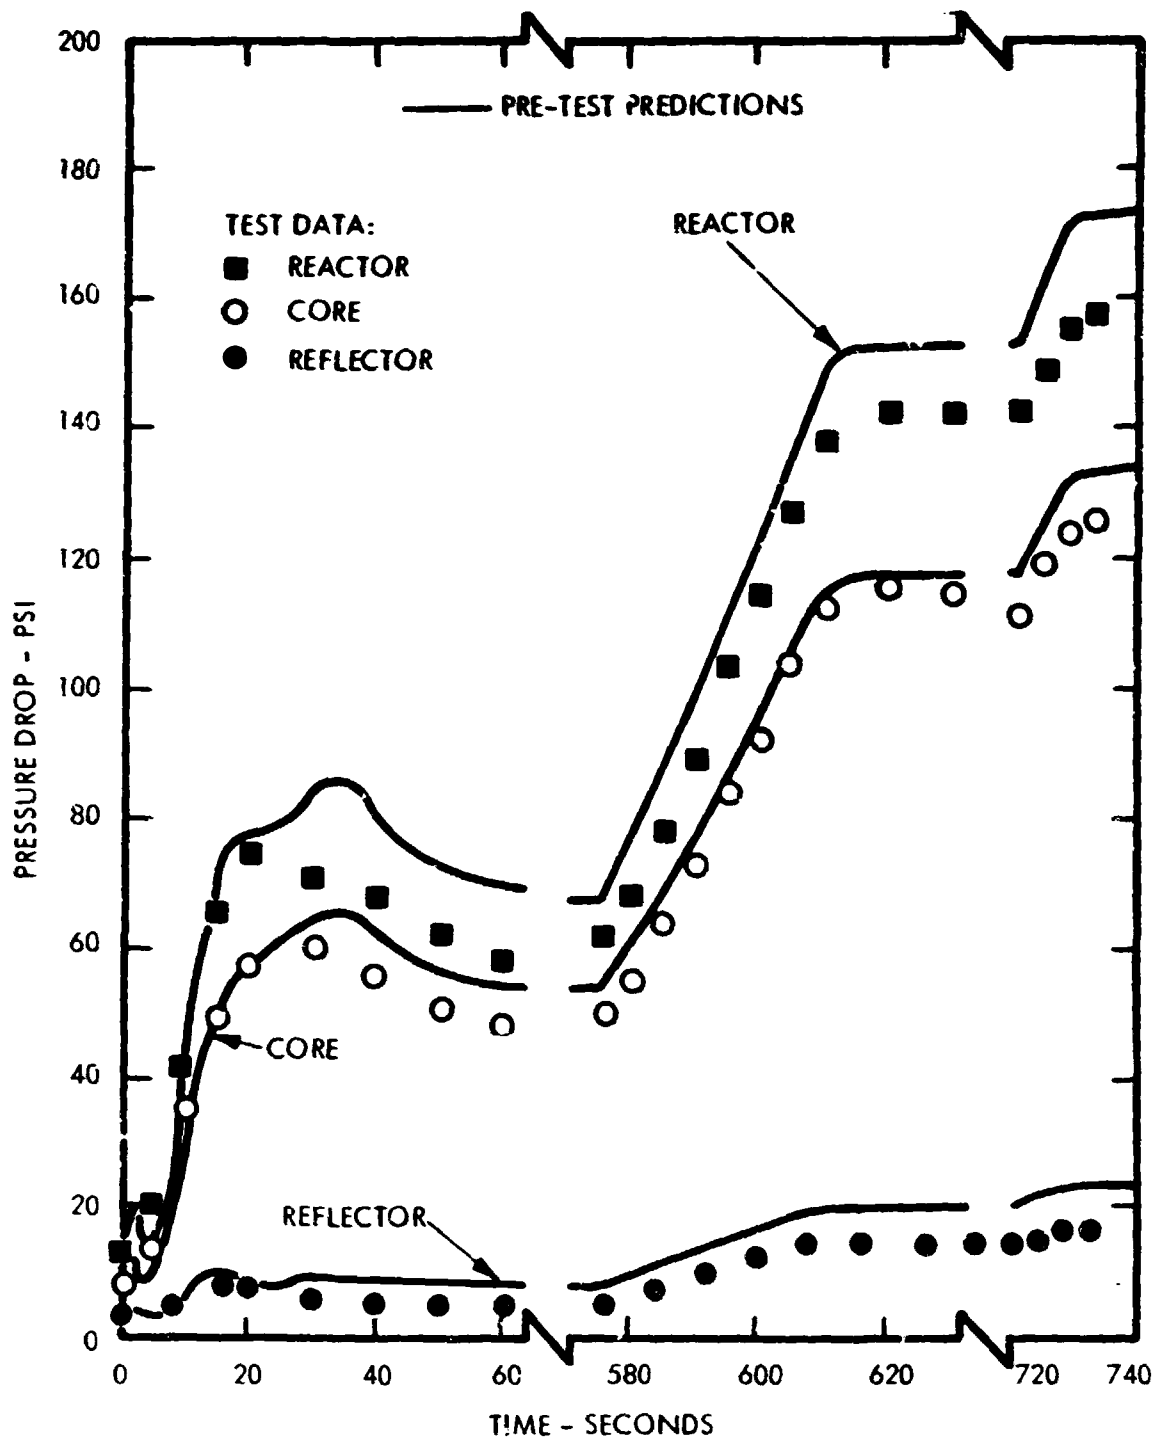
Figure 5-j. (U) Comparison of Component Pressure Drop Predictions with Measurements During EP IIIA Startup

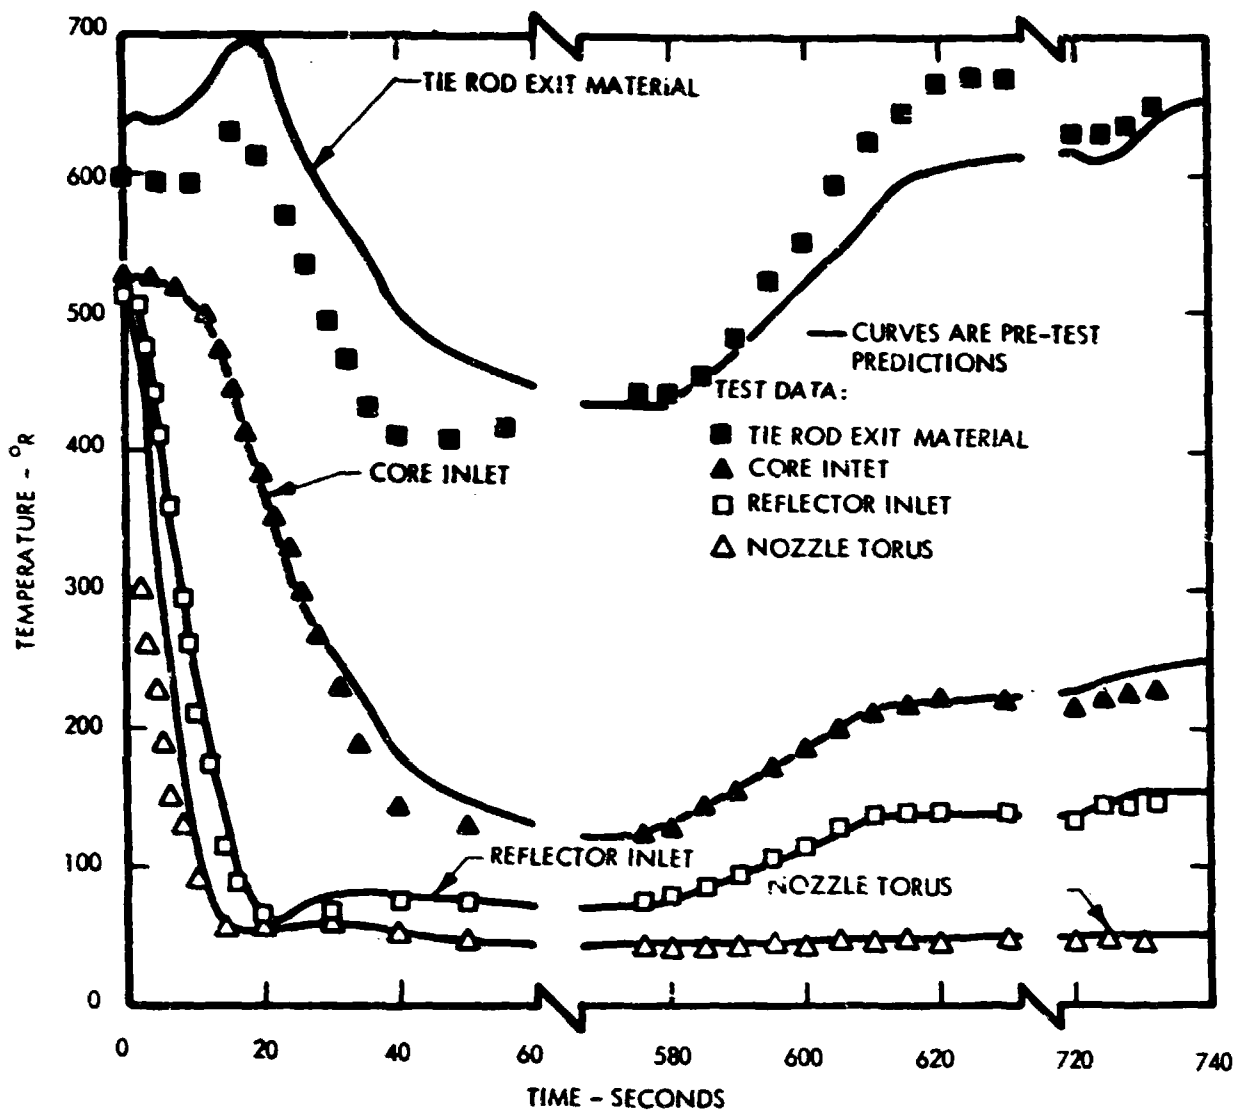
Figure 5-4. (CRD) Comparison of Tie Rod Exit Material and Reactor Plenum Temperature Predictions with Measurements During EP-IIIA Startup (U)

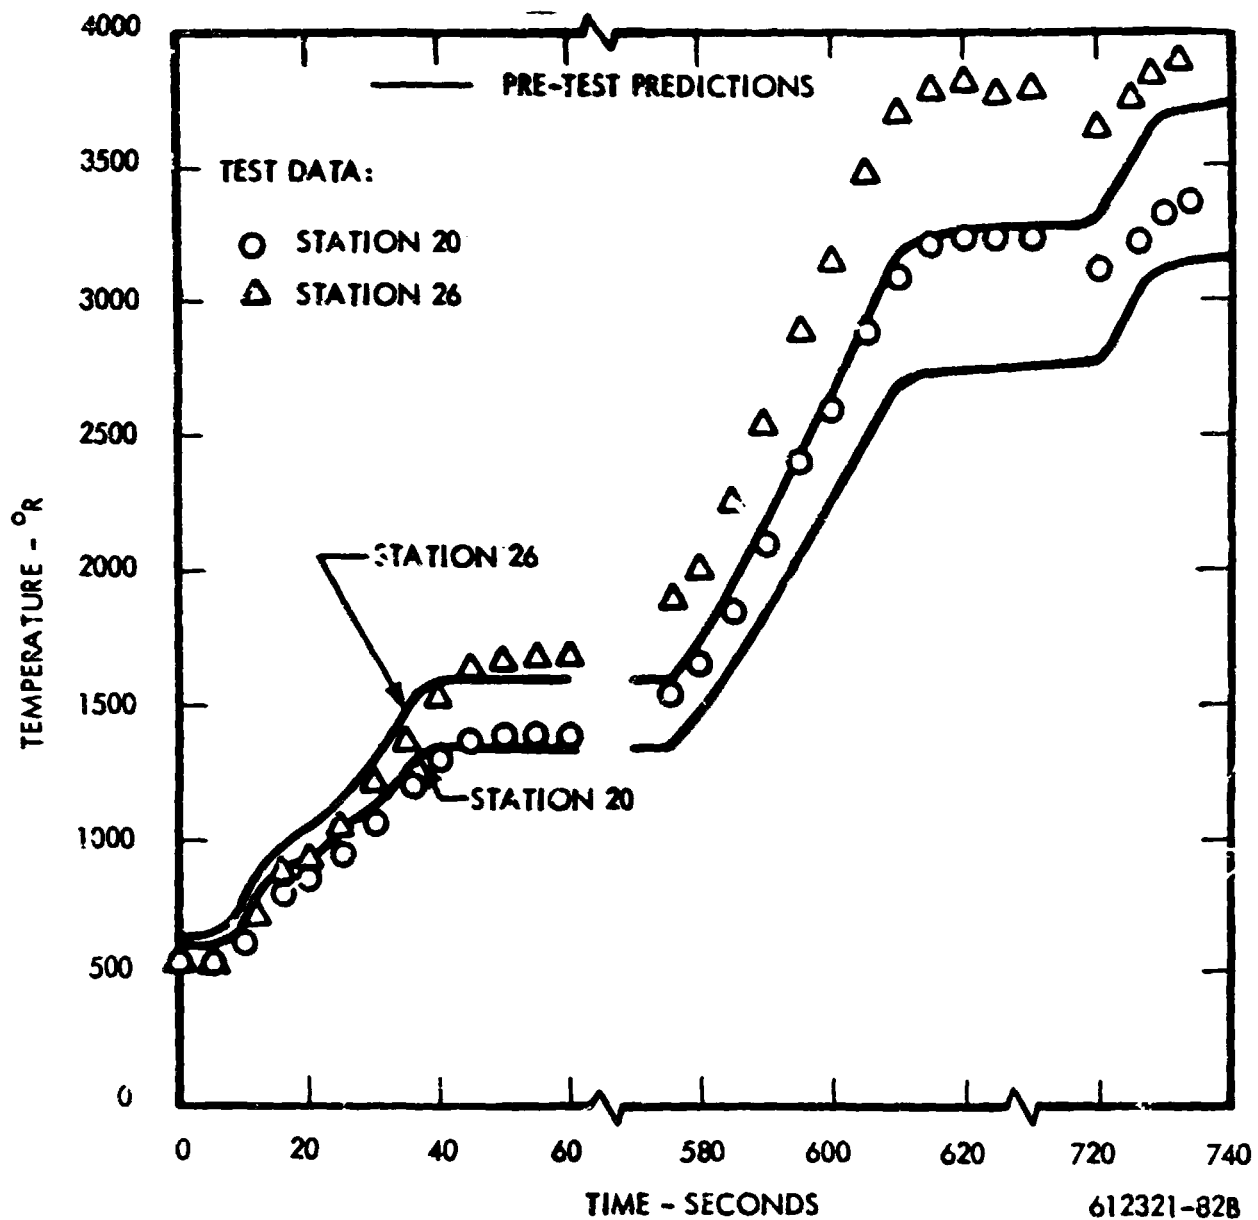
Figure 5-5. (CRD) Comparison of Core Station Temperature Predictions with Measurements During EP-IIIA Startup (U)

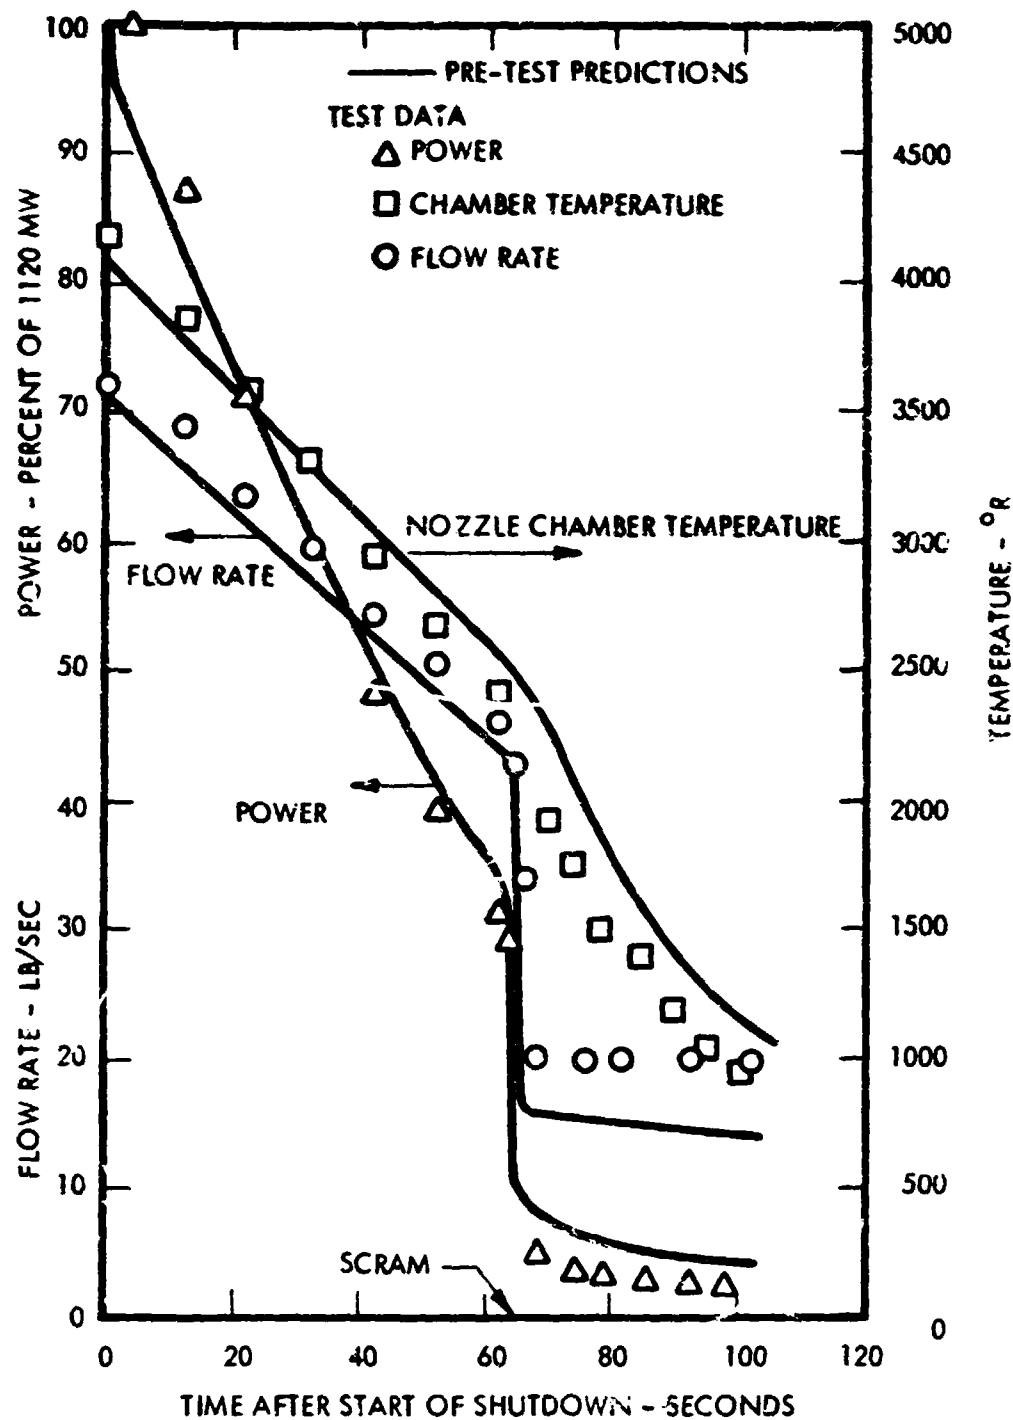
Figure 5-6. (CRD) Comparison of Power, Nozzle Torus Flow, and Chamber Temperature Predictions with Measurements During EP-IIIA Shutdown (U)

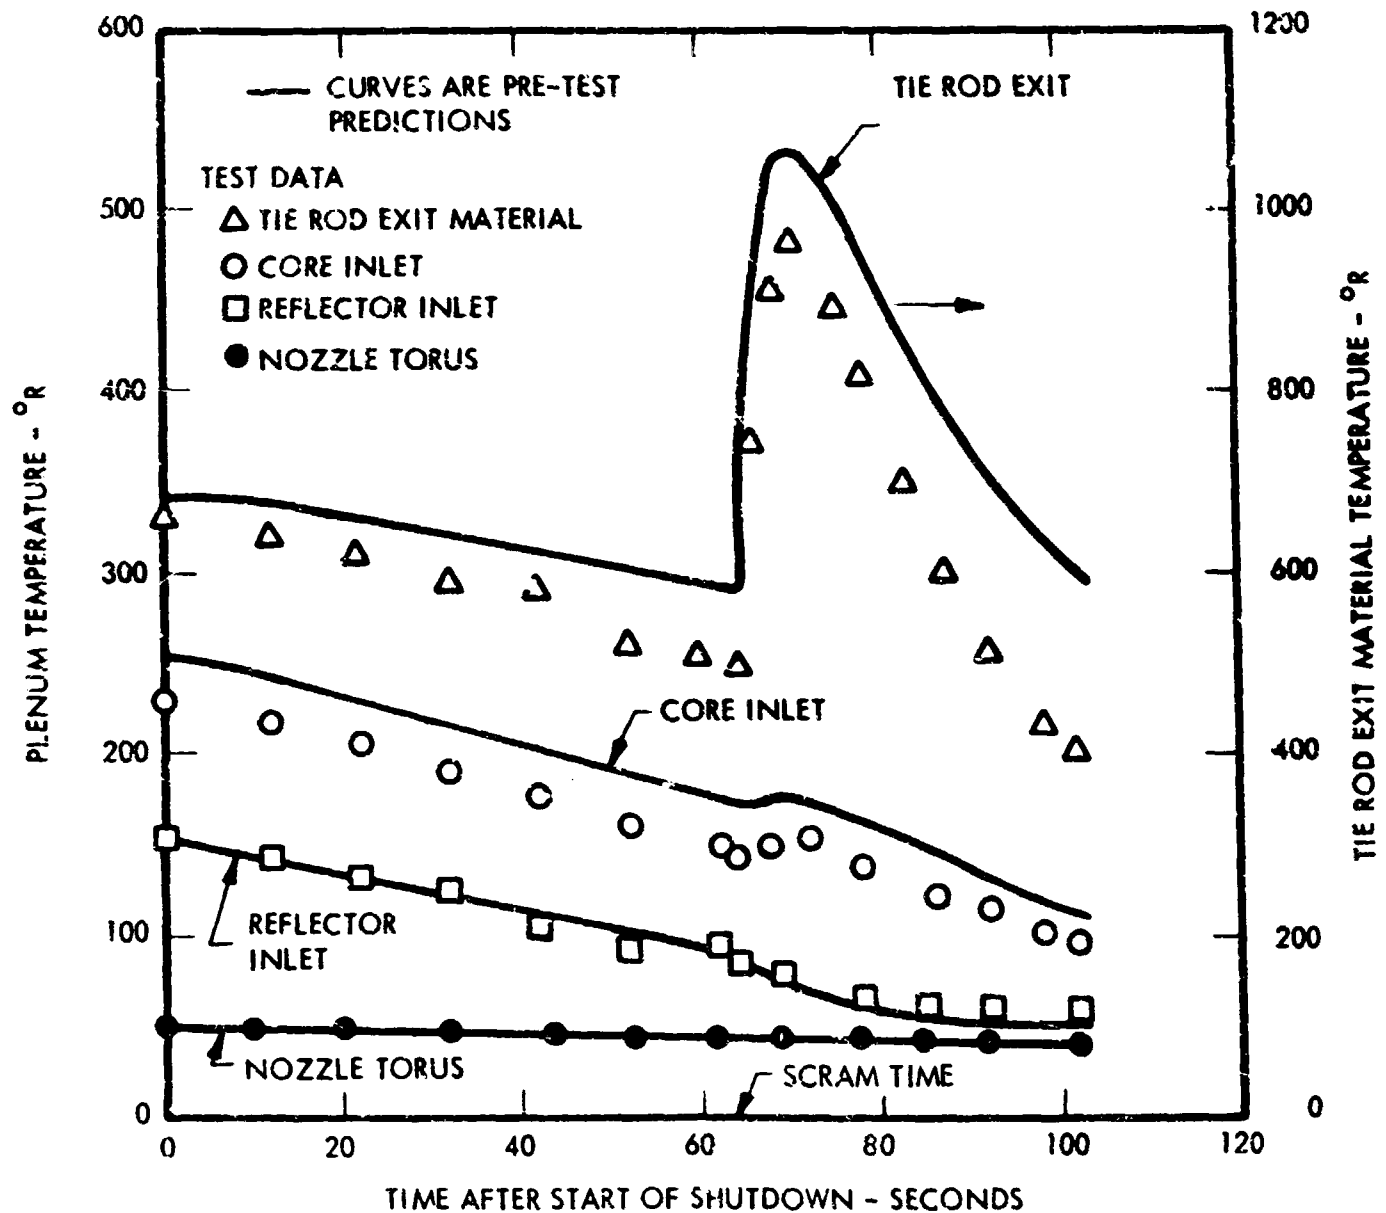
Figure 5-7. (CRD) Comparison of Tie Rod Exit Material and Reactor Plenum Temperature Predictions with Measurements During EP-IIIA Shutdown (U)

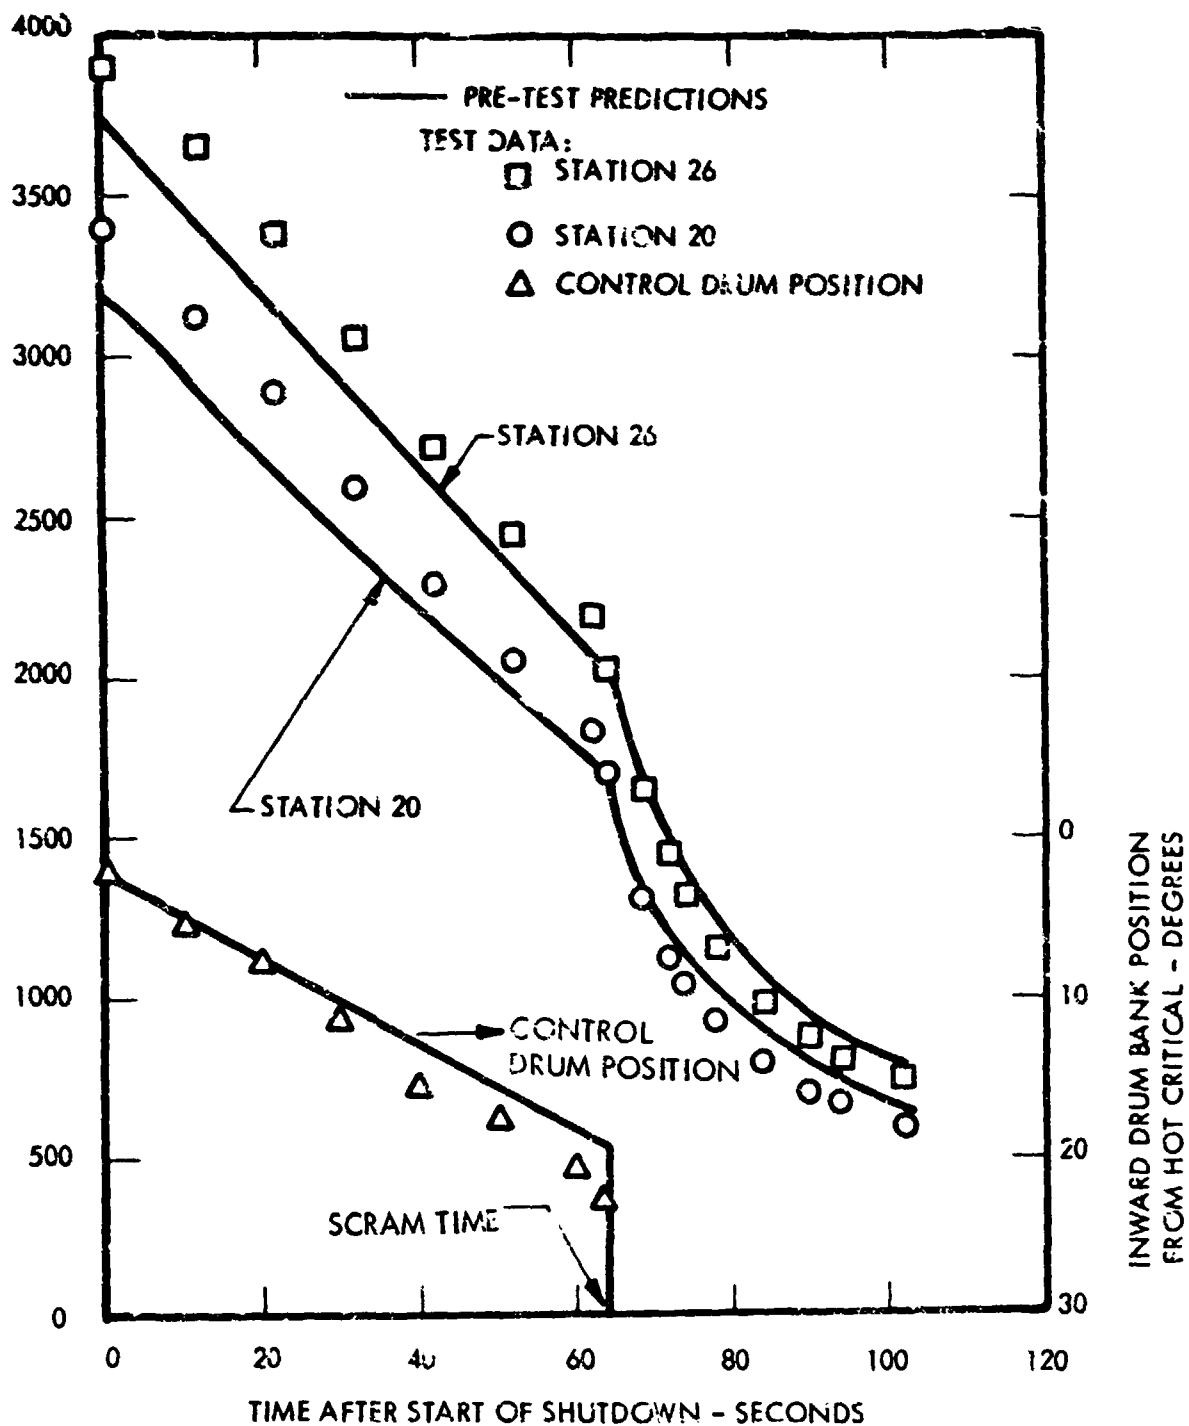
Figure 5-8. (CRD) Comparison of Core Station Temperatures and Control Drum Motion Predictions with Measurements During EP-III A Shutdown (U)

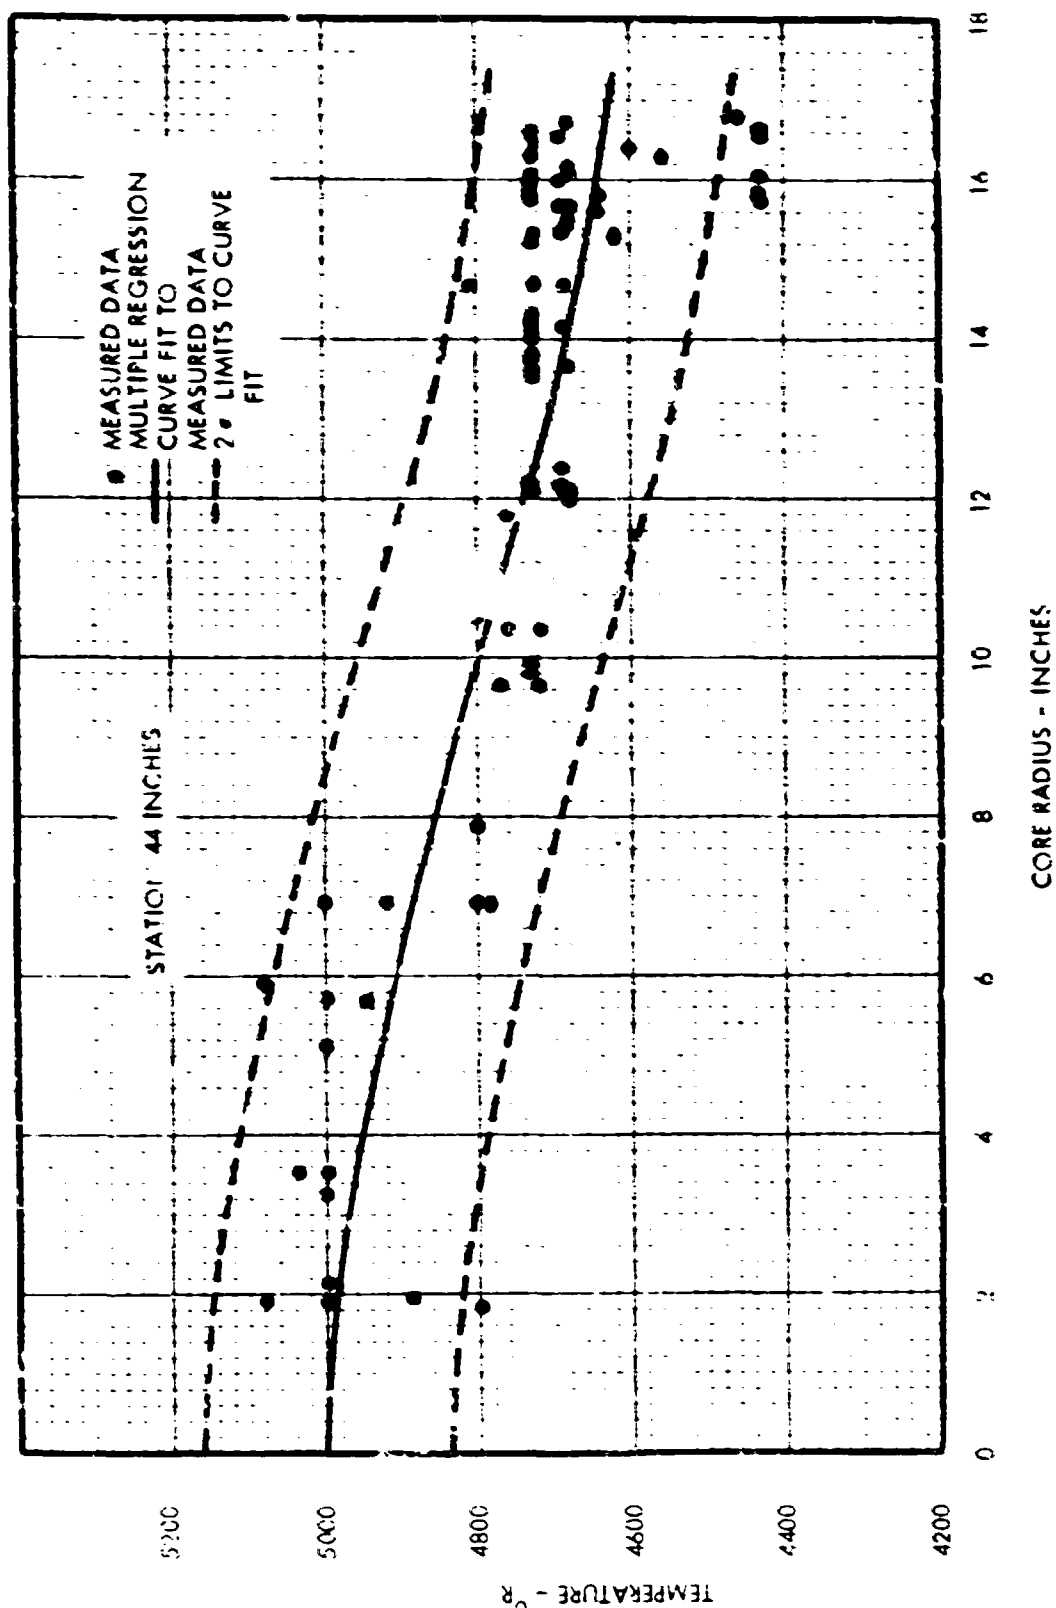
Figure 5-9. (CRD) NRX/A6 Thermal Capsule Temperatures vs Core Radius (U)

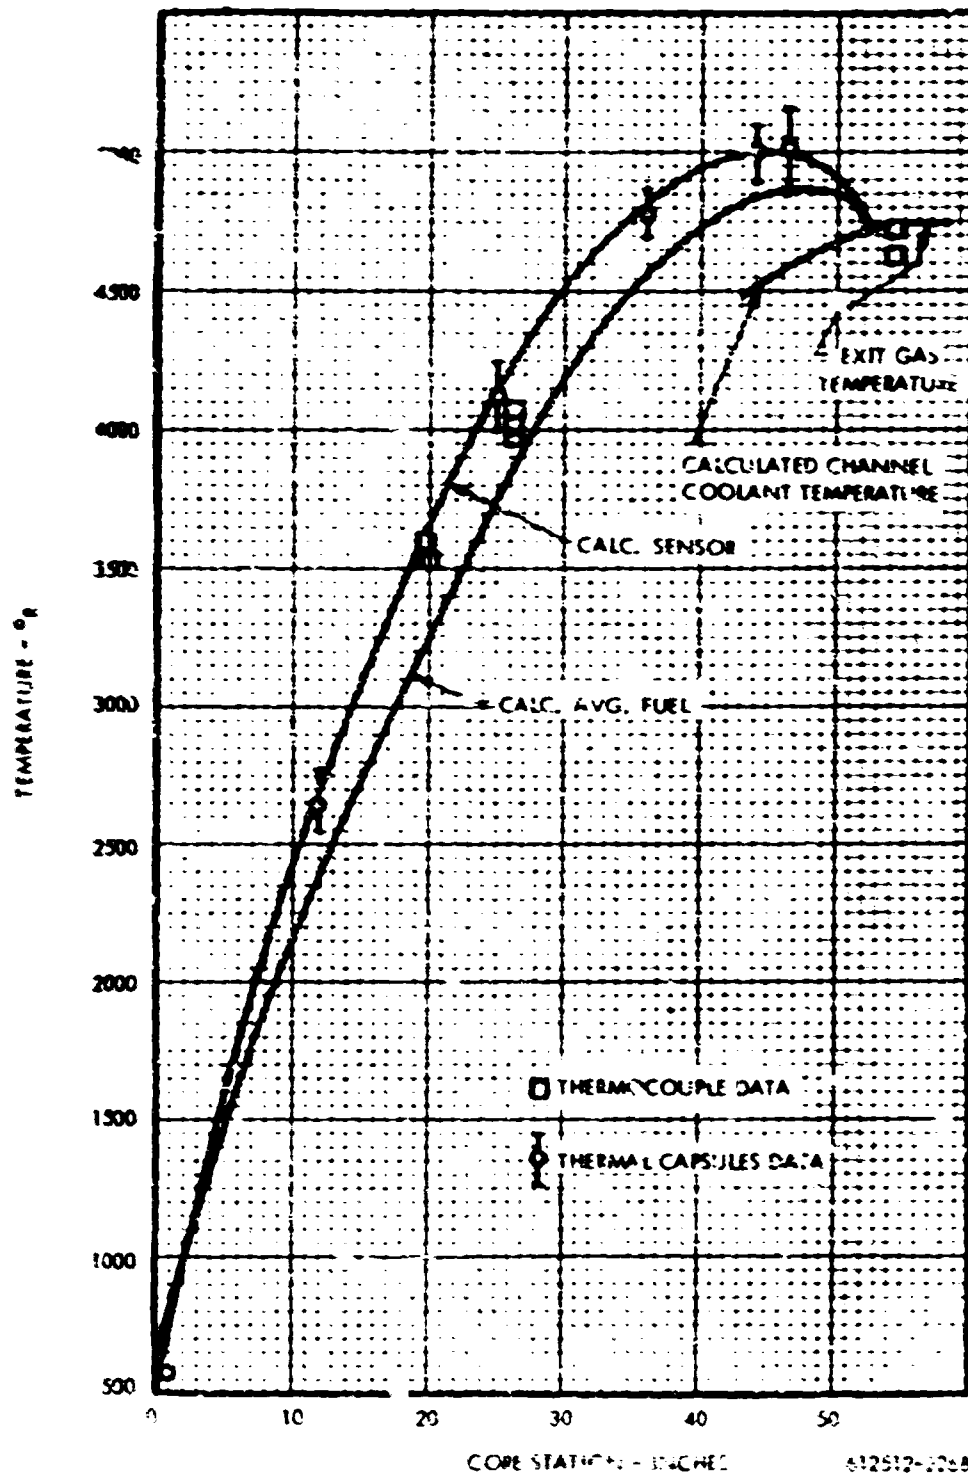
Figure 5-10. (CRD) Central Region, Total Temperature Distribution EP-111A at CRT 14300 (0)

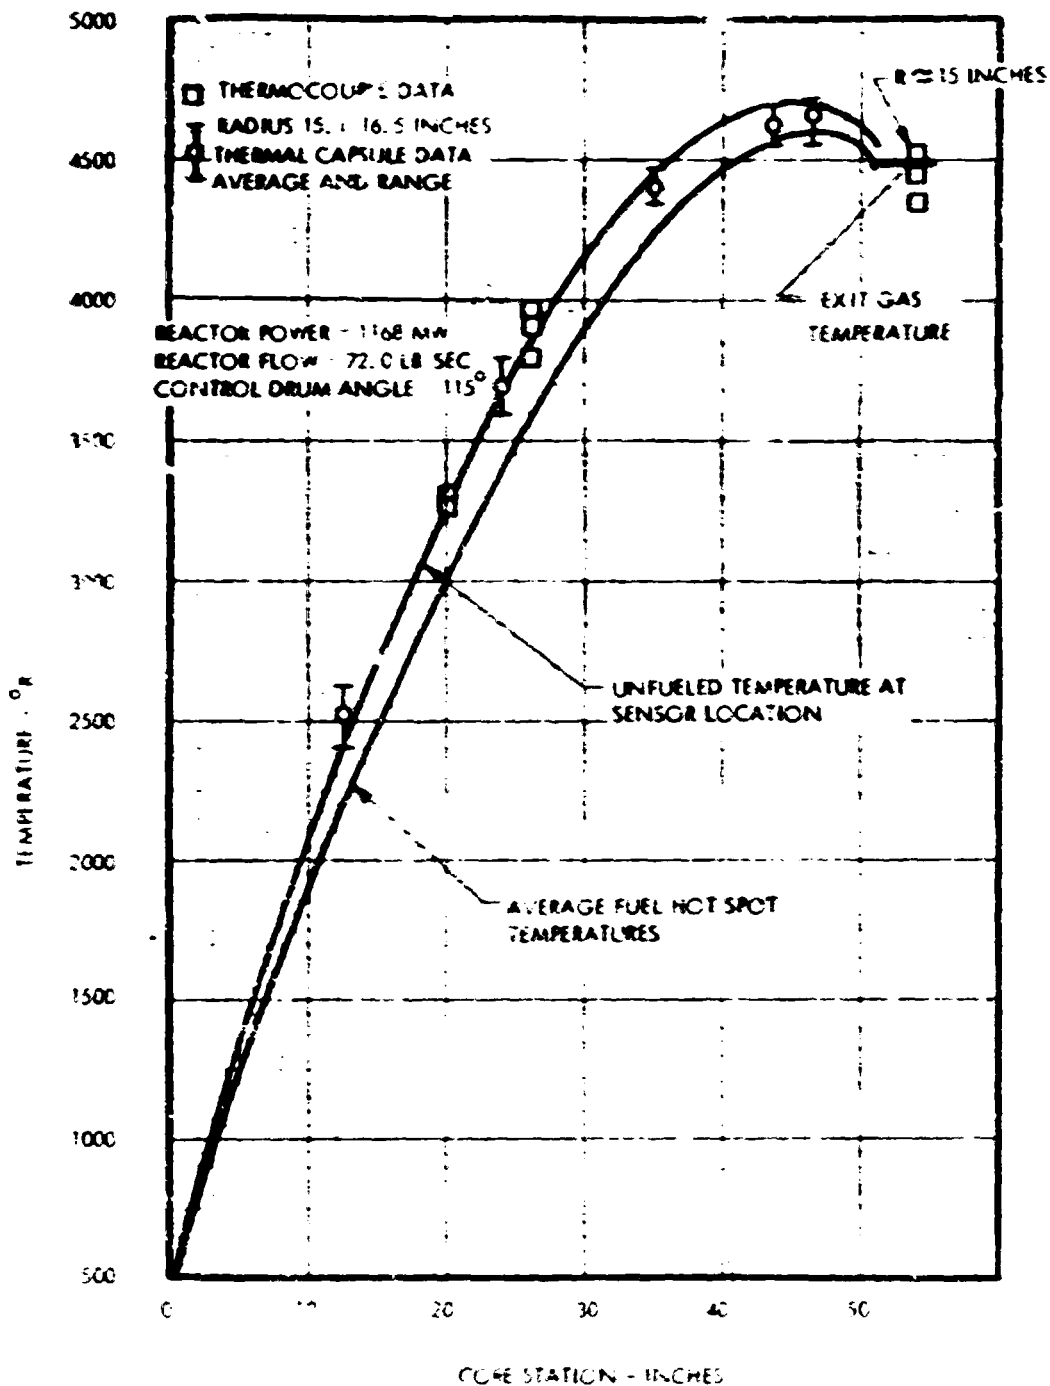
Figure 5-11. (CRD) Peripheral Region Axial Temperature Distribution for EP-III A at CRT 17600 (U)

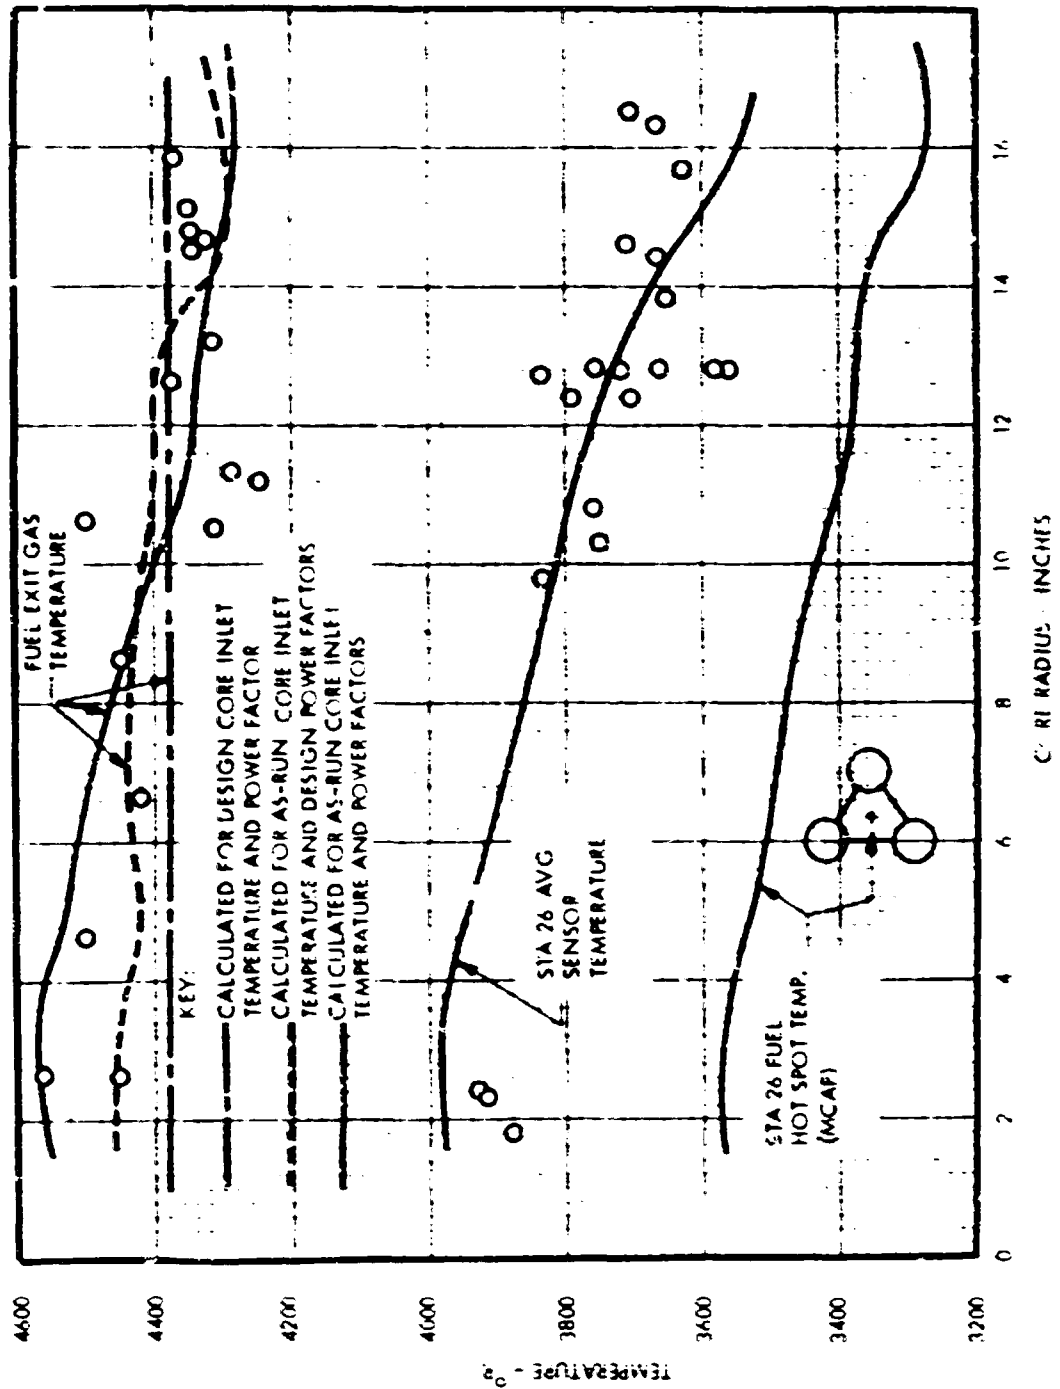
Figure 5-12. (CRD) Core Temperatures Versus Radius During EP-111A at CRT 14400 and Drum Position 105" (U)

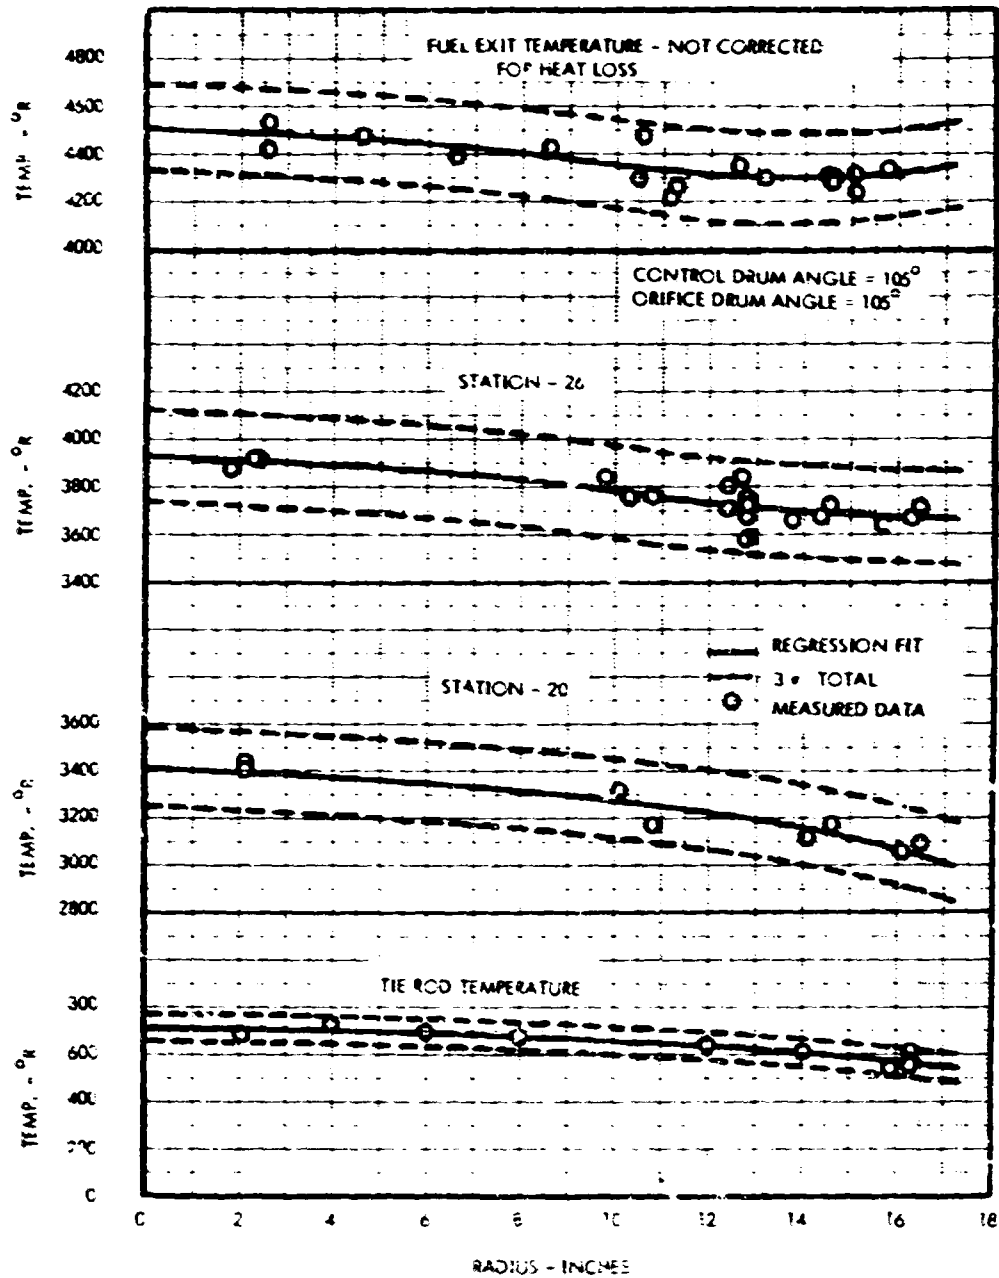
Figure 5-13. (CRD) Radial Core Temperature Distributions Obtained From Multiple Regression Analysis, EP-IIIA at CRT 14400 (U)

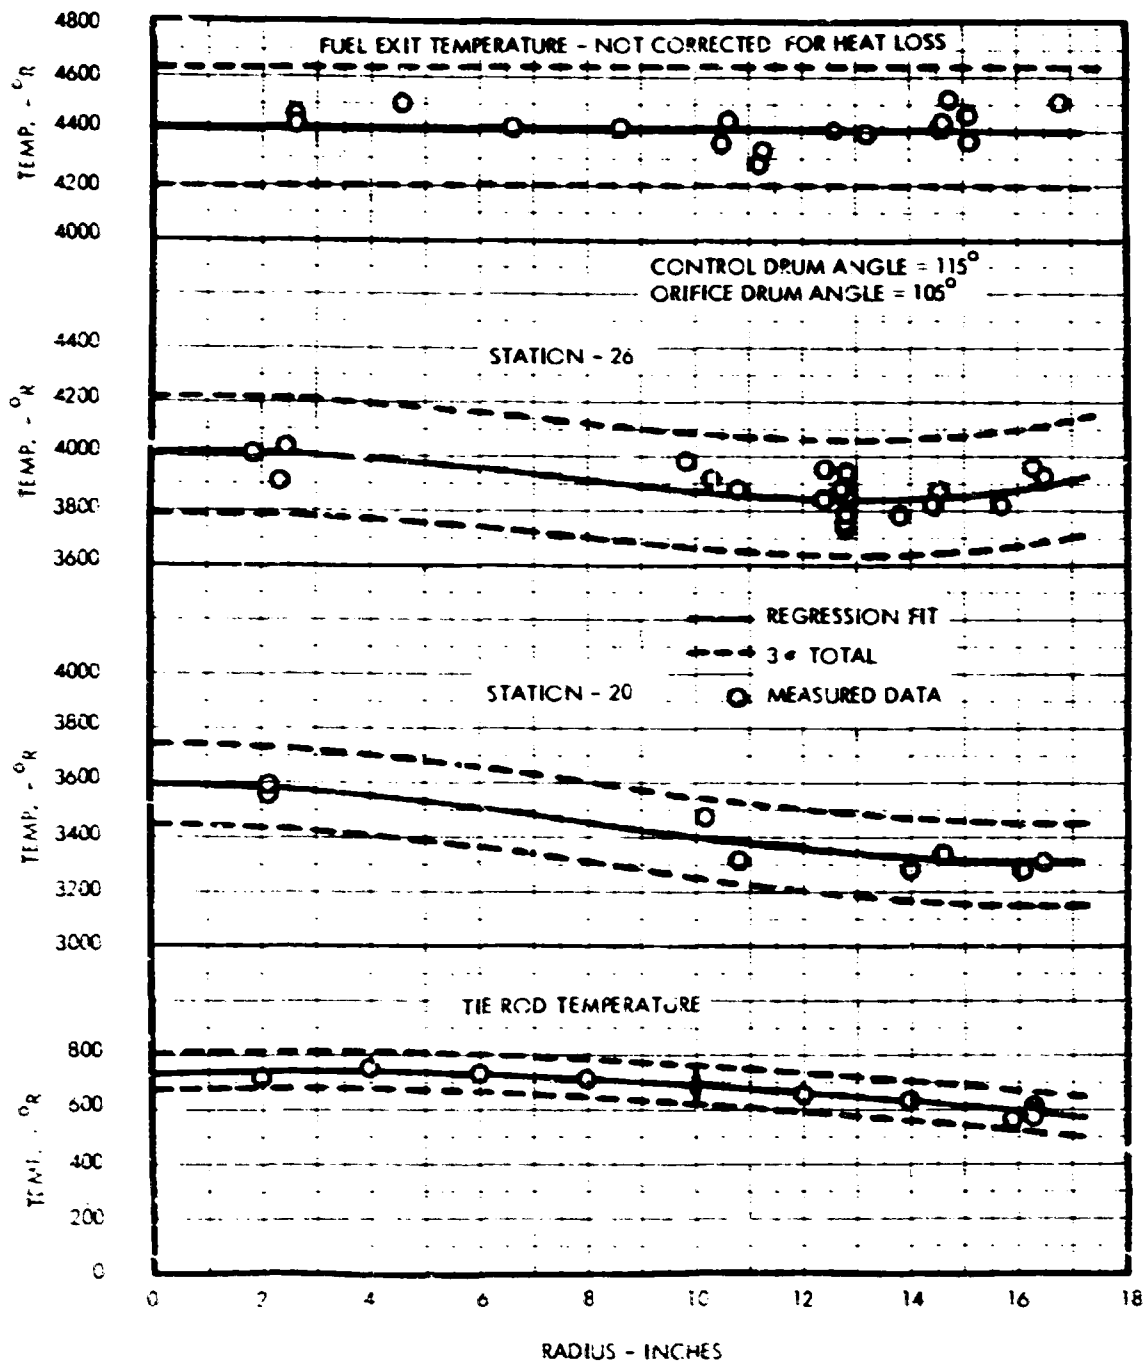
Figure 5-14. (CRD) Radial Temperature Distributions Obtained From Multiple Regression Analysis, EP-IIIA at CRT 17800 (U)

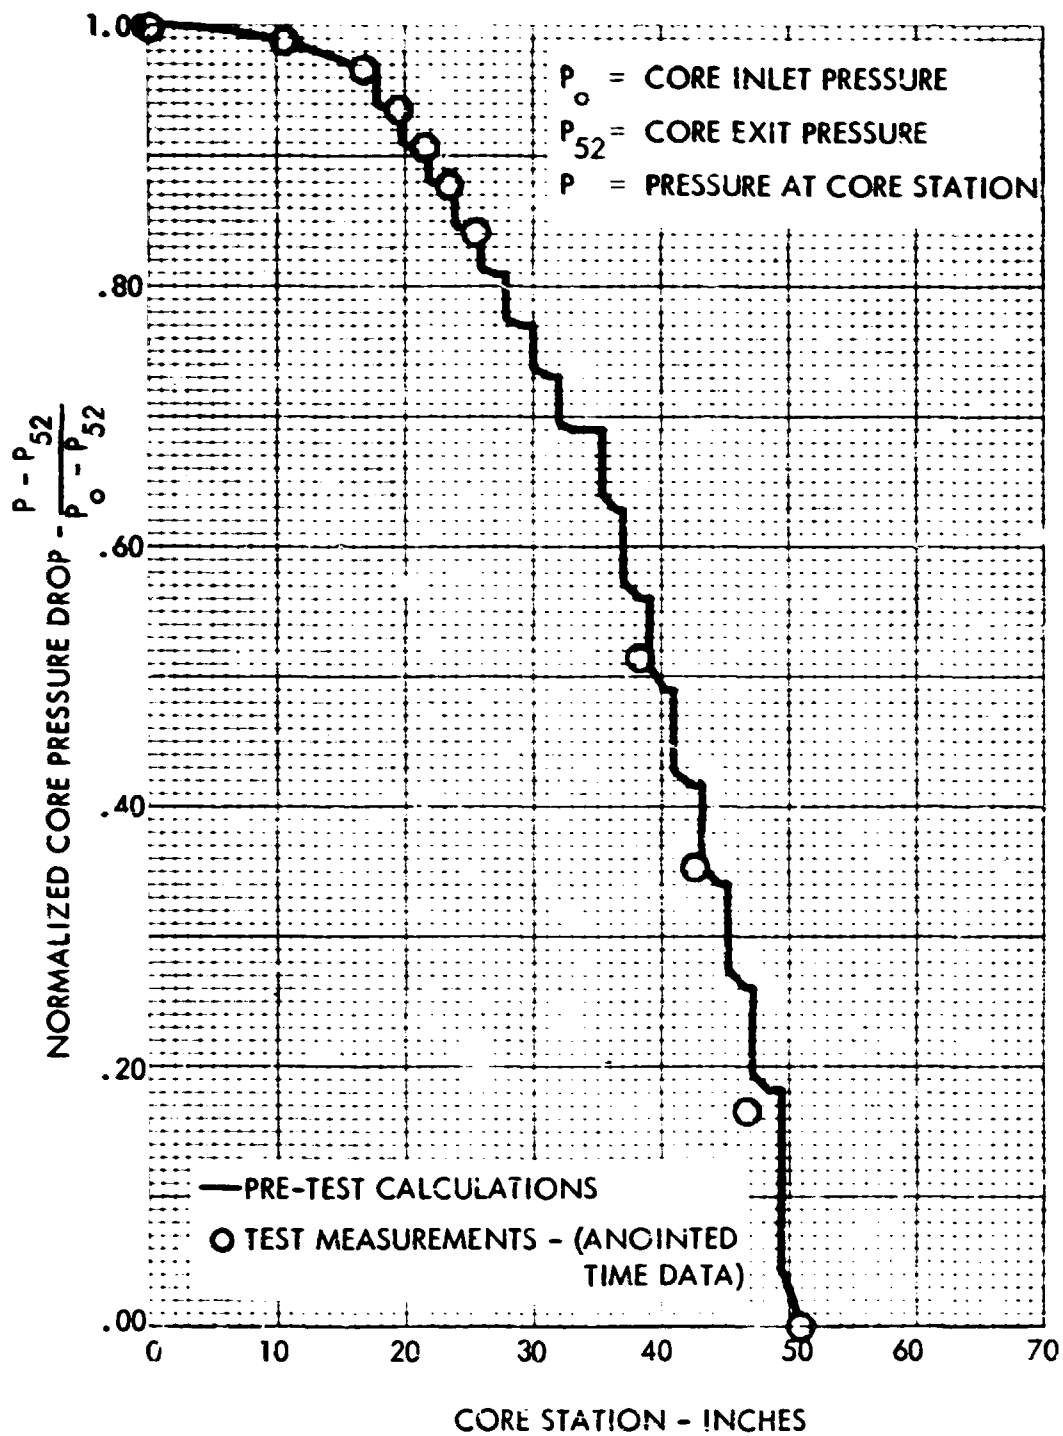
Figure 5-15. (CRD) Normalized Lateral Support Seal System Pressure Distribution During EP-IIIA Full Power Hold (U)
